Proof Testing to Achieve H-20 Load Rating Of Septic Tanks Reinforced With Macro Fibers

**By: Ed Pennypacker
JEPCOSALES, LLC**

**Wednesday May 29, 2013
Guardian Concrete
2140 Maxon Road
Schenectady, NY 12308**

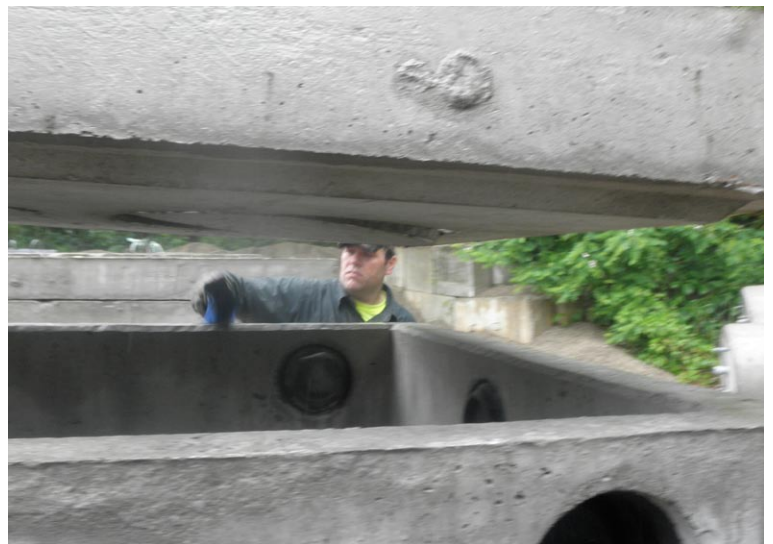
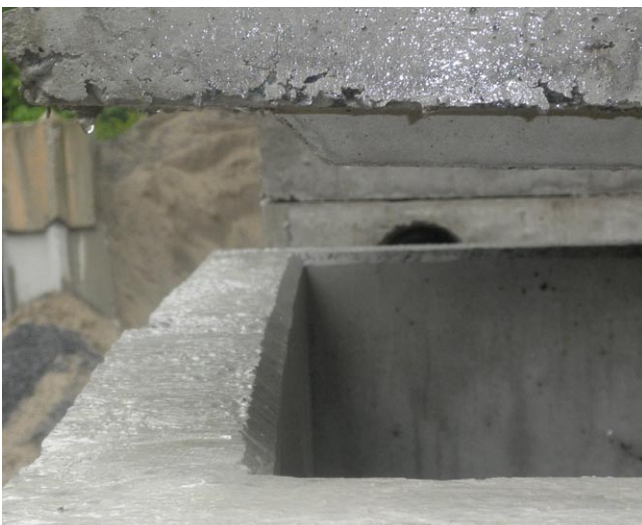
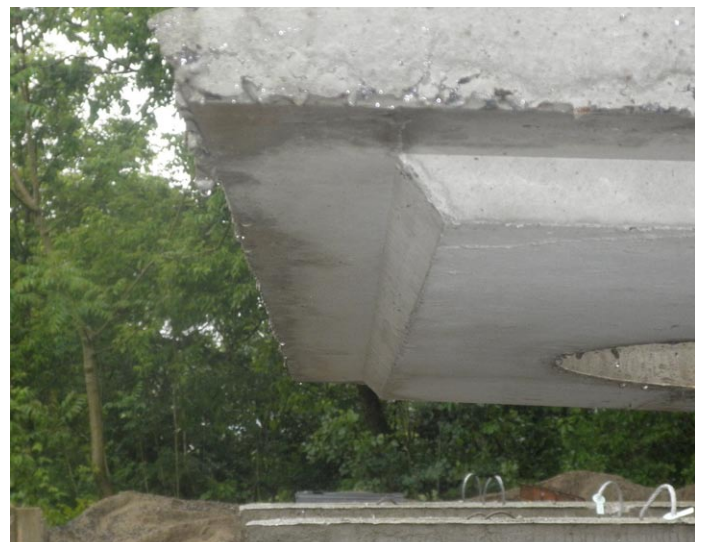
Since the test procedure applies such a high physical load, most of which, impacts the side walls, it is important to have an interaction between the side walls and the top slab. While the engineer showed a rectangular portion on the top slab, Guardian chose to produce the bevel, which was easier to assemble. As the vacuum test proceeded, pressure forced downward on the top and inward on the walls. The two bevelled edges help each other withstand the forces without damage.

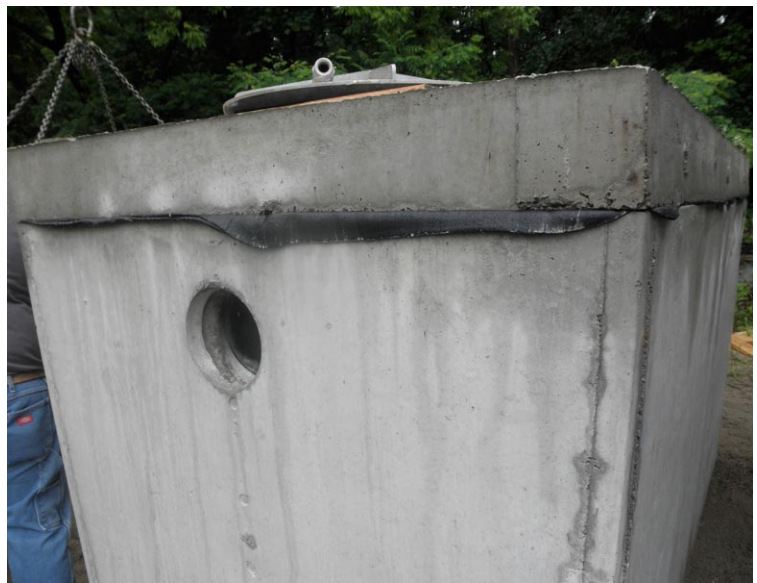
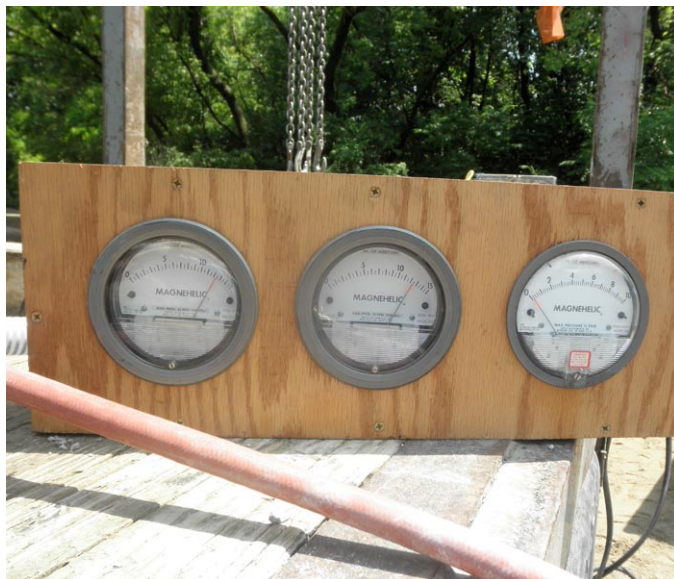
At 12.5 inches of Hg on the gauges, the tanks passes the requirements for H-20 loading. Nine pounds of Macrofiber per yard of concrete was used as the primary reinforcement in the sidewalls of the tank. The floor and roof are reinforced as directed by engineer’s design. There is no steel in any of the sidewalls.

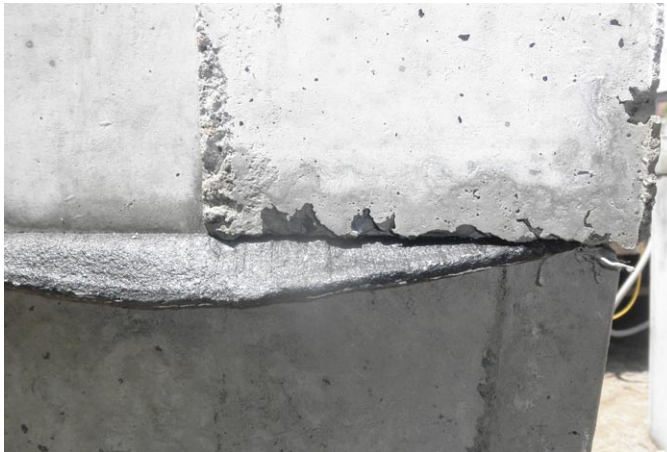
A tank made similarly with only six pounds per yard developed a tiny crack at 10.0 inches of Hg on the gauge. Without the safety factor included, this tank also passed the H-20 loading criterion. A slight defect in the lid may have caused the crack. (See below, "Problems")

A tank made exactly as shown by engineer's design, with steel reinforcement in top, floor, and sides, developed a tiny crack at 10.0 inches of Hg on the gauge. This tank is H-20 rated by Engineer's Design. The identical tiny crack appears to be related to the irregularity in the lid. The crack was in the same place and of the same size in both cases.

Notice the jagged edge along the bottom of the lid. There is an irregularity which allowed "mold flash", a condition where a bit of the concrete leaked from the mold and then hardened into "teeth". Concrete is very susceptible to point loading. The two tanks that cracked developed small, almost invisible cracks in the same location, directly under the irregularity. That mold flash was chipped away, before testing, on the tank reinforced with nine pounds of macrofiber per yard. If it had been noticed and removed, it is possible that all three tanks would have made it through 12.5 inches of Hg.
