Proof Testing to Achieve H-20 Load Rating Of Septic Tanks Reinforced With Macro Fibers

**By: Ed Pennypacker
JEPCOSALES, LLC**

**Wednesday May 29, 2013
Guardian Concrete
2140 Maxon Road
Schenectady, NY 12308**

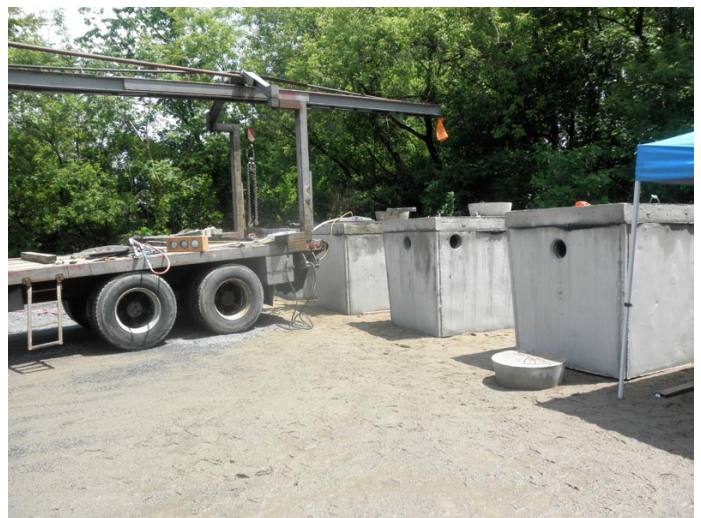
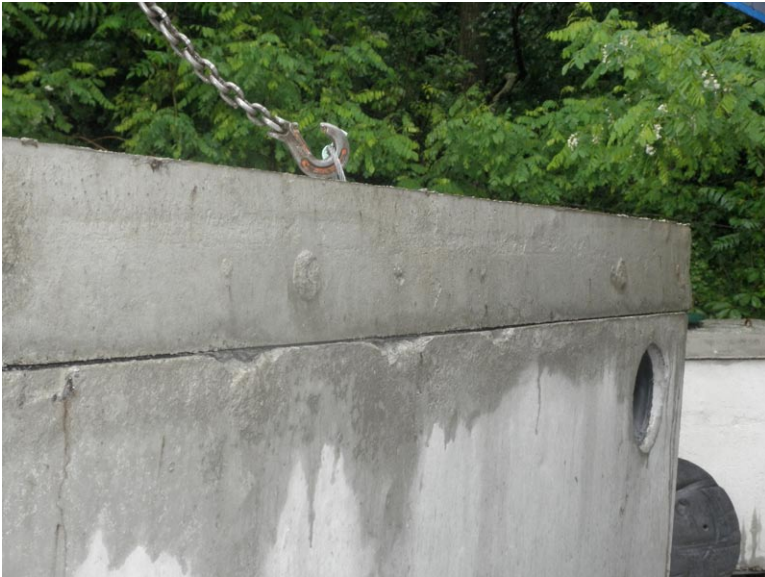
The top slab is poured in a separate adjustable mold. The top of the tank portion is hand finished by one of the workers. The dry fit was pretty good. There were some spots with irregularities, so additional thickness of ConSeal CS-102 butyl gasket was employed to seal the joint.

While the truck held the top slab, Bill brushes the concrete to insure a good seal.

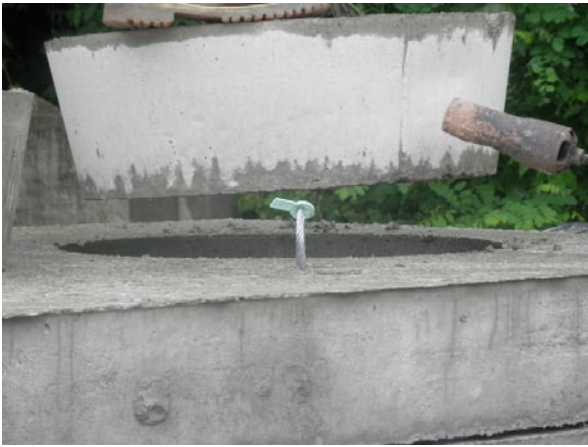
The manhole opening at one end of the tank had to be torch dried. Then it was sprayed with adhesive, which held in place a special gasket from ConSeal, CS-367.

CS-367 seals well enough to prevent leaks, but after the test, it easily releases. Regular CS-102 would seal so tightly that it would cause damage to unseal the structure.

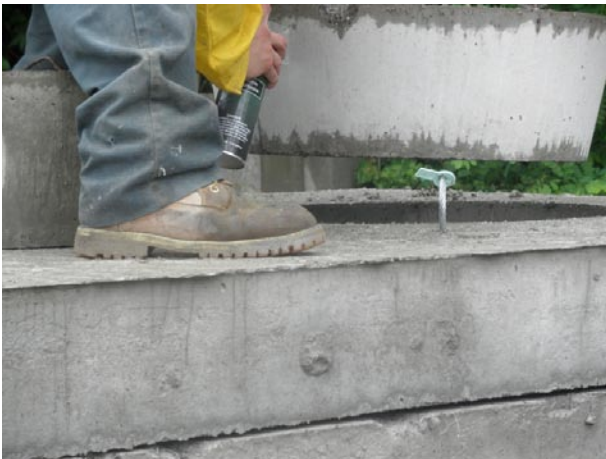
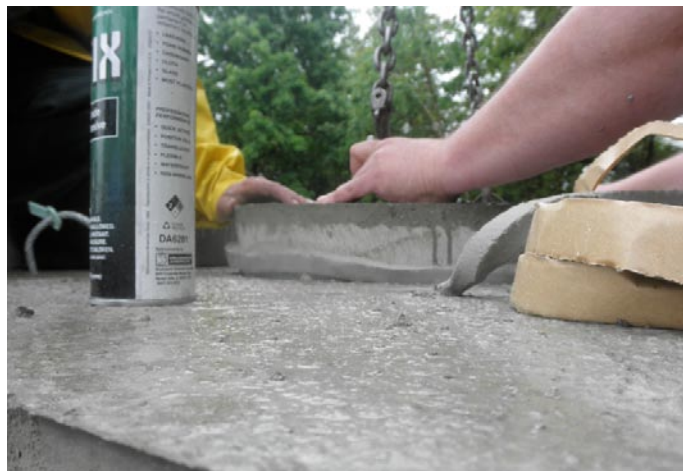
During the test, the manhole plug was sucked down into the opening. The gray CS-367 prevents leaks, while allowing easy disassembly. JEPCO SALES, LLC provided the test equipment. One end of the tank was sealed with CS-367 while the other end provided access to the tank for the equipment. Because the 24 inch openings are tapered, the 26 inch diameter test plate would not cover the opening. Plywood with CS-367 under it, and with an opening cut in it helped seal the opening

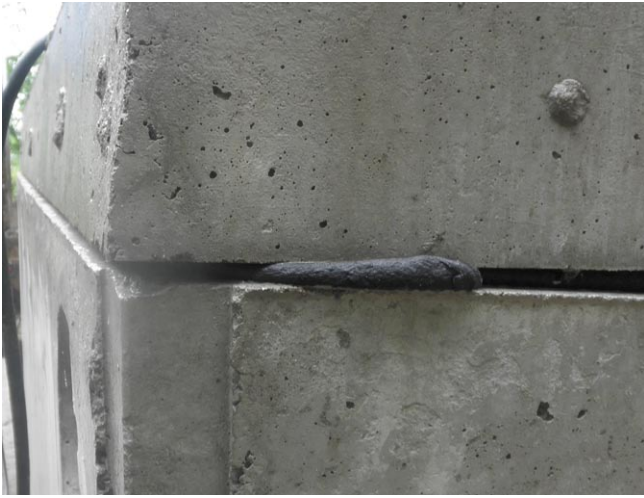
CS-102 is a black butyl gasket. The weight of the concrete compresses it. Some excess butyl “squeezes out” indicating sufficient gasket material is in the joint to make a water tight seal. Neither water nor air ever passes through the gasket. In case of a leak, water sneaks past the gasket, where compression is insufficient. At least 50% compression is the goal.

Vacuum pressures exert a lot of force on a tank. When that happens, more of the butyl gasket squeezes out of the joint. As air is drawn from inside the tank, air pressure on the outside pushes inward on all six sides. The downward pressure is increased enough that we can simulate expected loads. A typical septic tank is buried less than three feet deep in a back yard. These tanks are made to sustain the weight of heavy trucks. They are suited to installations in parking lots and driveways.

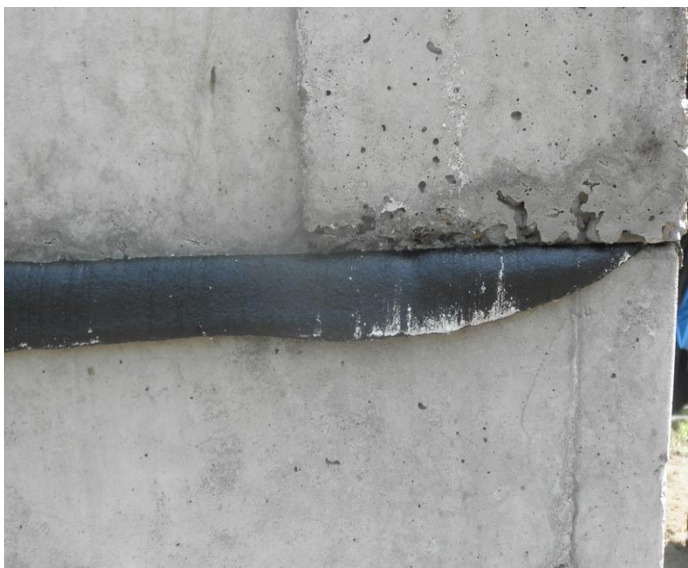
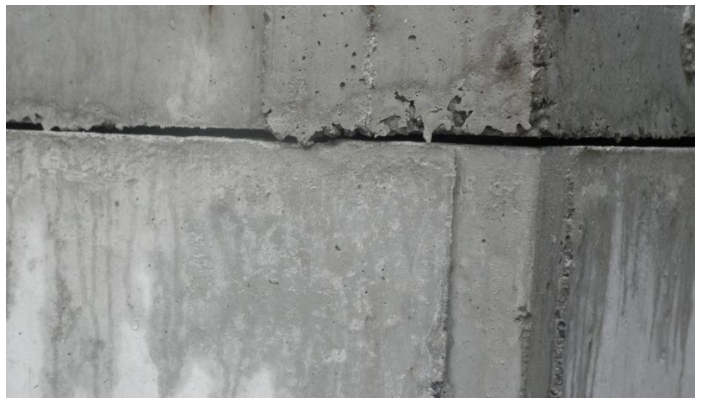
A tank made similarly with only six pounds per yard developed a tiny crack at 10.0 inches of Hg on the gauge. Without the safety factor included, this tank also passed the H-20 loading criterion. A slight defect in the lid may have caused the crack. (See below, "Problems")

A tank made exactly as shown by engineer's design, with steel reinforcement in top, floor, and sides, developed a tiny crack at 10.0 inches of Hg on the gauge. This tank is H-20 rated by Engineer's Design. The identical tiny crack appears to be related to the irregularity in the lid. The crack was in the same place and of the same size in both cases.

Notice the jagged edge along the bottom of the lid. There is an irregularity which allowed "mold flash", a condition where a bit of the concrete leaked from the mold and then hardened into "teeth". Concrete is very susceptible to point loading. The two tanks that cracked developed small, almost invisible cracks in the same location, directly under the irregularity. That mold flash was chipped away, before testing, on the tank reinforced with nine pounds of macrofiber per yard. If it had been noticed and removed, it is possible that all three tanks would have made it through 12.5 inches of Hg.
