JEPCO NEWS

CAN VENTING HELP WITH MIC?

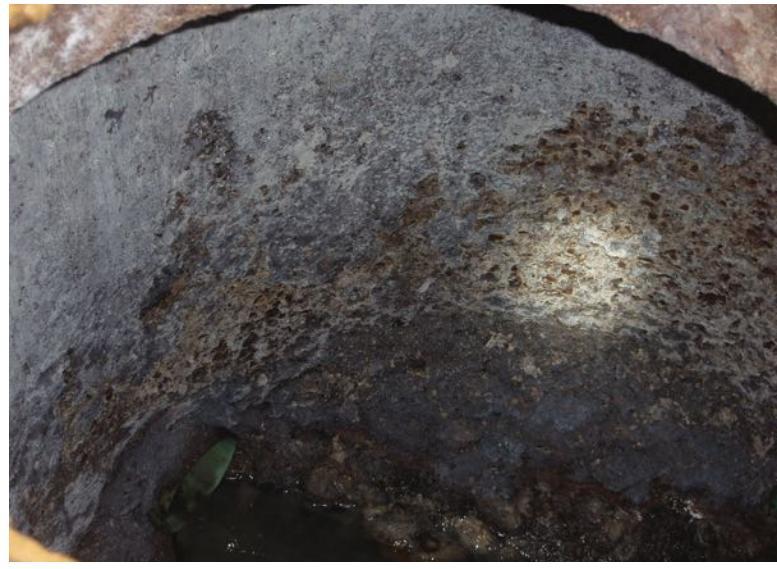
Corrosion of the concrete surface near the invert of a sewer manhole

What happened? A family of microbes (Thiobacillus bacteria) that live on a sewer gas called Hydrogen Sulfide (H_2S) colonized on the concrete surface and their waste, excreted as a nasty form of Sulfuric Acid (H_2SO_4), corroded the surface of the concrete.

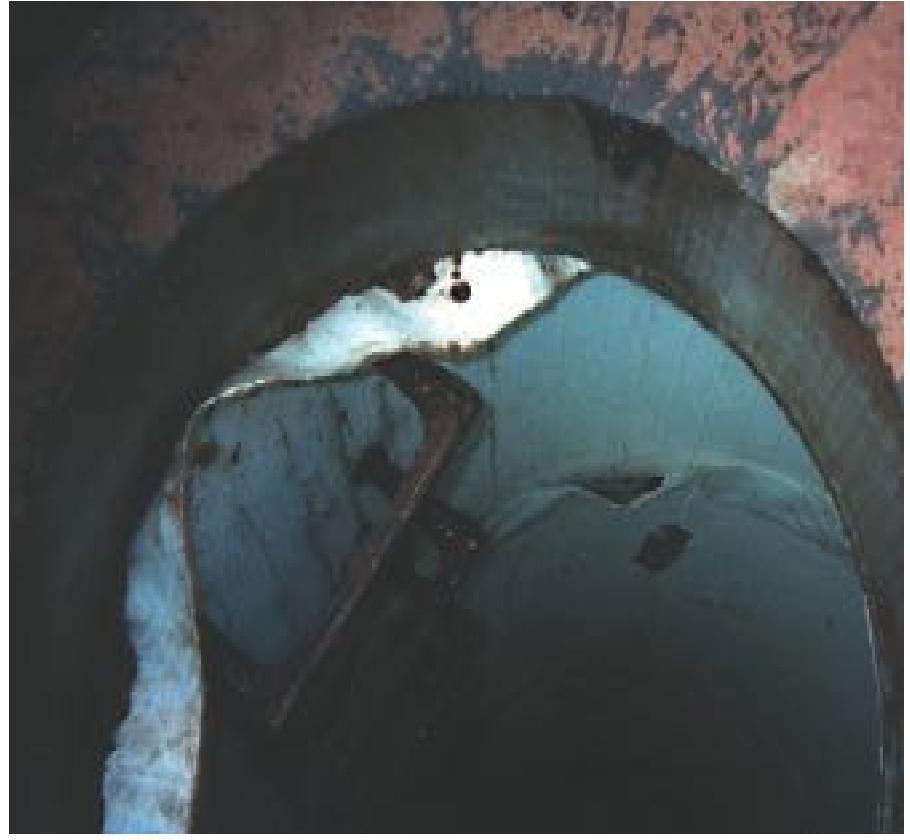
PVC liner in a manhole. This was not installed correctly. Already, the joint is exposed due to a poor weld. In the worst case, the liner will fall into the base and block the sewer line.

If it is not possible to reduce turbulence, as in force mains, where sewage is pumped into the system, then the concrete has to be protected from MIC. One way, is to install liners to cover the surface with acid resistant plastic. This is best done at the time of manufacture. It CAN be done later, but it is tricky and expensive. Plastic liners add \$15.00 or more per square foot of surface. Done correctly they will protect the concrete from MIC. They have been known to peel off, which cancels their effectiveness.(Below)

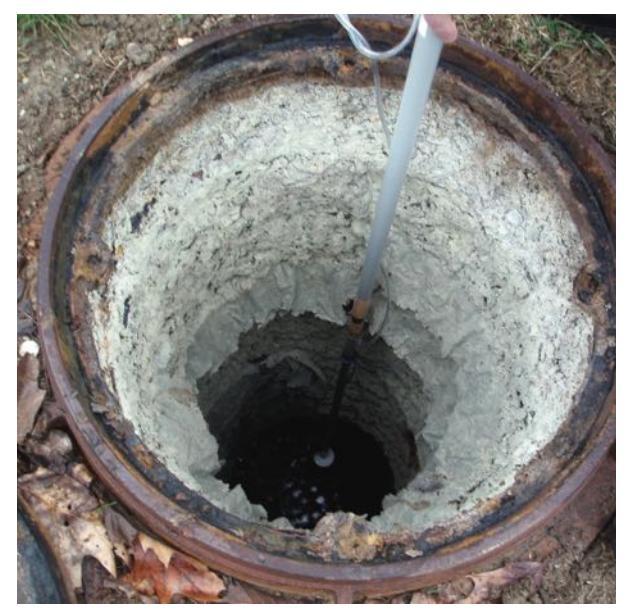
Left-Concrete Riser with MIC. The attack causes concrete to change to soft white Gypsum, which looks and feels like mashed potatoes.

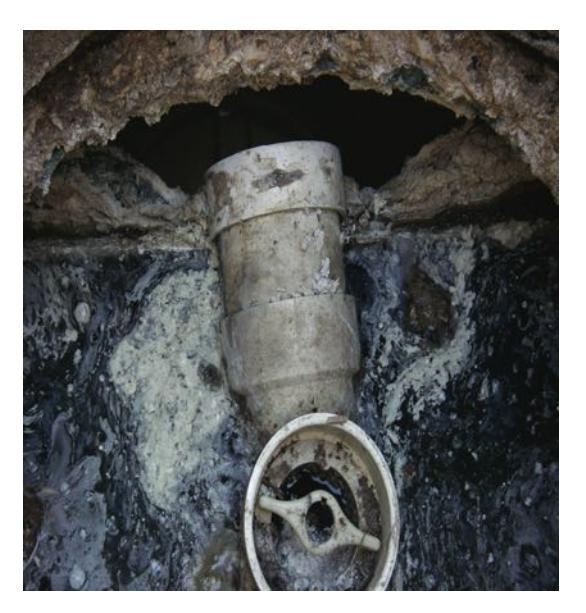
Right- Extreme MIC at the outlet of a septic tank. The concrete is eaten all the way through
